Cornwall Industrial Settlements Initiative
BOTALLACK and TRUTHWALL
(St Just Area)

CORNWALL INDUSTRIAL SETTLEMENTS INITIATIVE

N. J. Cahill
and
Cornwall Archaeological Unit

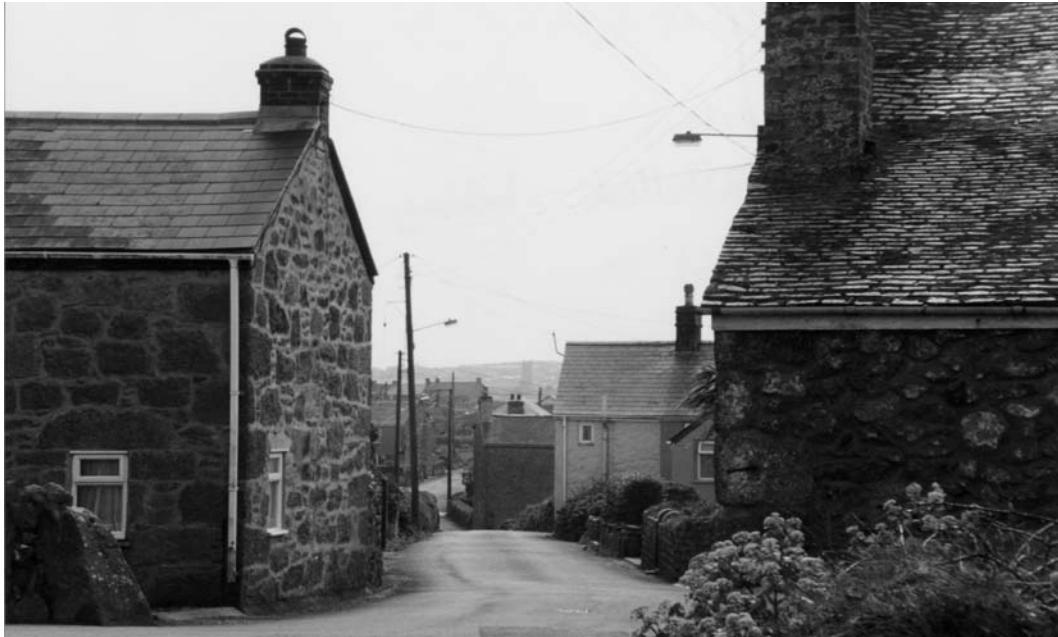
Figure 5 The main street of Botallack looking south with St Just church tower in the distance; serried ranks of little-altered granite walled and slate roofed cottages gable end to the road, the earlier ones each in their own distinct enclosure. Although the street contains many bungalows, they do not intrude into the scene or dominate the historic character. Gazetteer items [49, 43, 48].

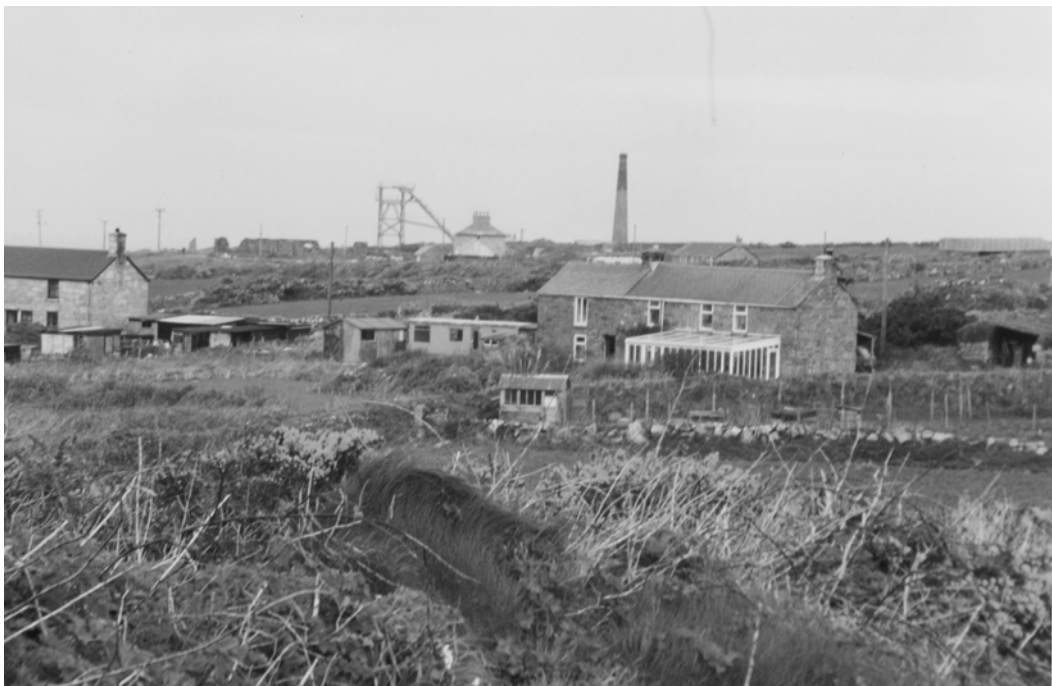
Figure 6 Looking north towards Botallack Mine from Parknoweth mine site: early cottages and smallholdings on the edge of commons and mine wastes; the mining heritage is never far distant, even if not always obvious from within the village. Gazetteer items [65, 64].

Management proposals and action are urgently required for the area of the Parknoweth mine, stretching up into the Botallack mine site. What is superficially a loose, untidy area of lanes, paddocks and dumps, and patches of old moor/waste, although much altered, still has some archaeological value, as well as being a wildlife habitat very different from the otherwise rather sterile farming landscape to the east, north and south of the village. In historic, amenity and visual terms, it is an asset that does much to relate the village to its setting. Existing policies, while tending to see much of the old mining areas as derelict land needing improvement, also allow for the historic and archaeological significance of such sites to be enhanced, and grant aid may be available for access, safety and minor clearance works to emphasise this aspect of the remains. The network of paths and open spaces leading to the more obvious tourist sites on the coast should be regarded as part of an integrated approach to the management of the area.

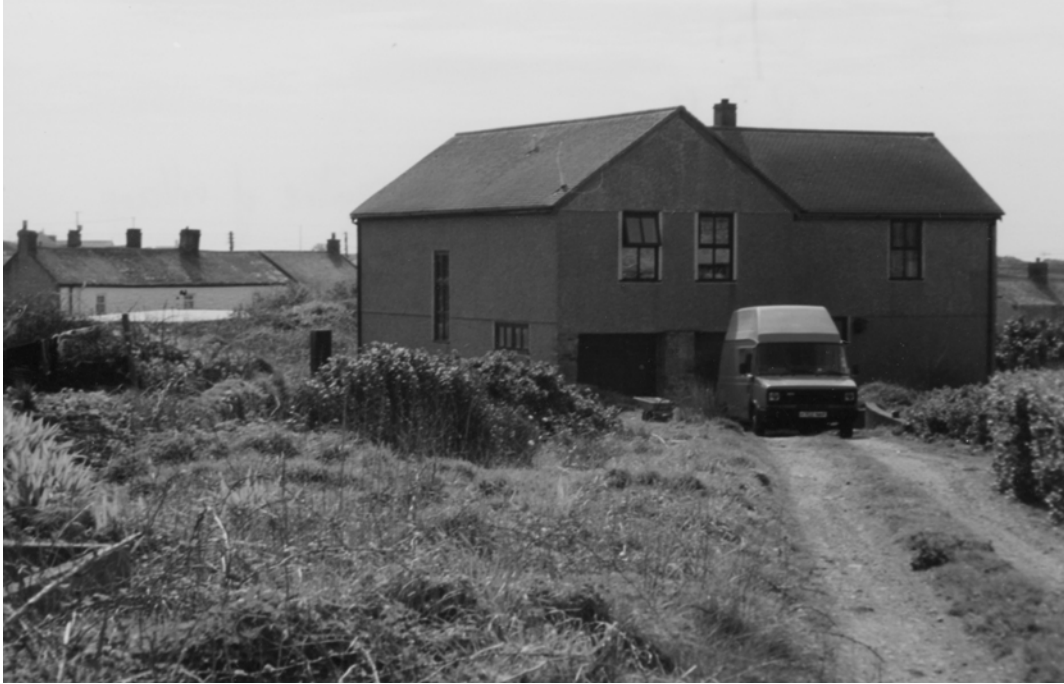
Figure 7 Some modern insertions in the village centre have not been successful in their choice of materials and scale. Gazetteer item [39] in the background.

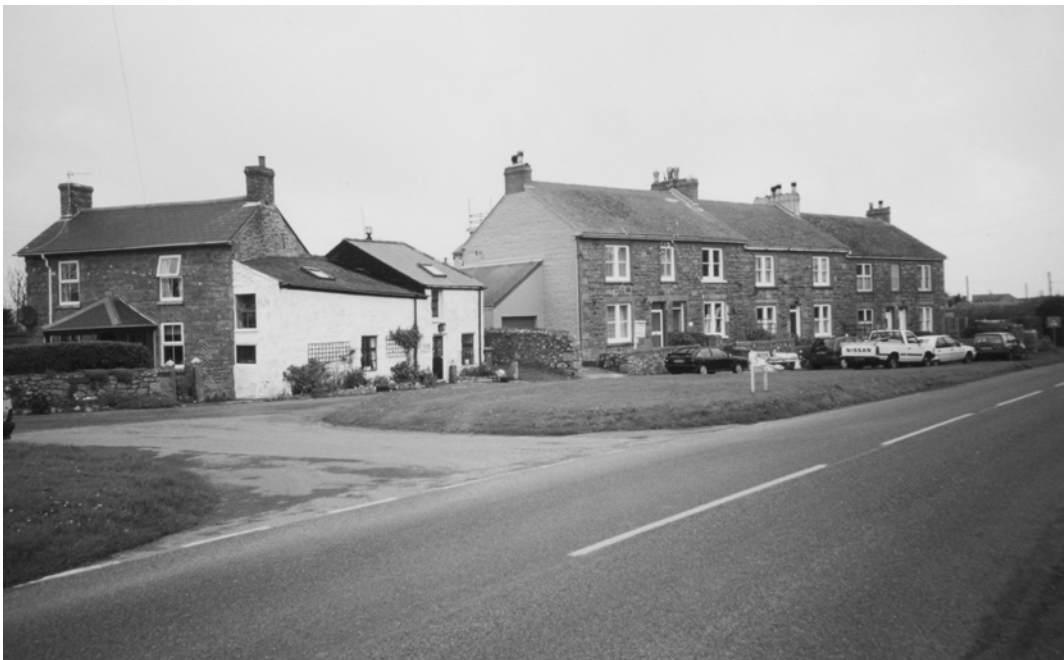
Figure 8 Truthwall; Pengale, Truthwall Cottage and Truthwall Terrace. An apparently timeless village green belies the rapid growth and decline of the village - the photograph is taken from the site of a demolished row of cottages, another stood to the left of Pengale Cottage, Truthwall Terrace is an addition of 1908, and the Green dates only from road improvements in the 1960s. Gazetteer items [28, 29].

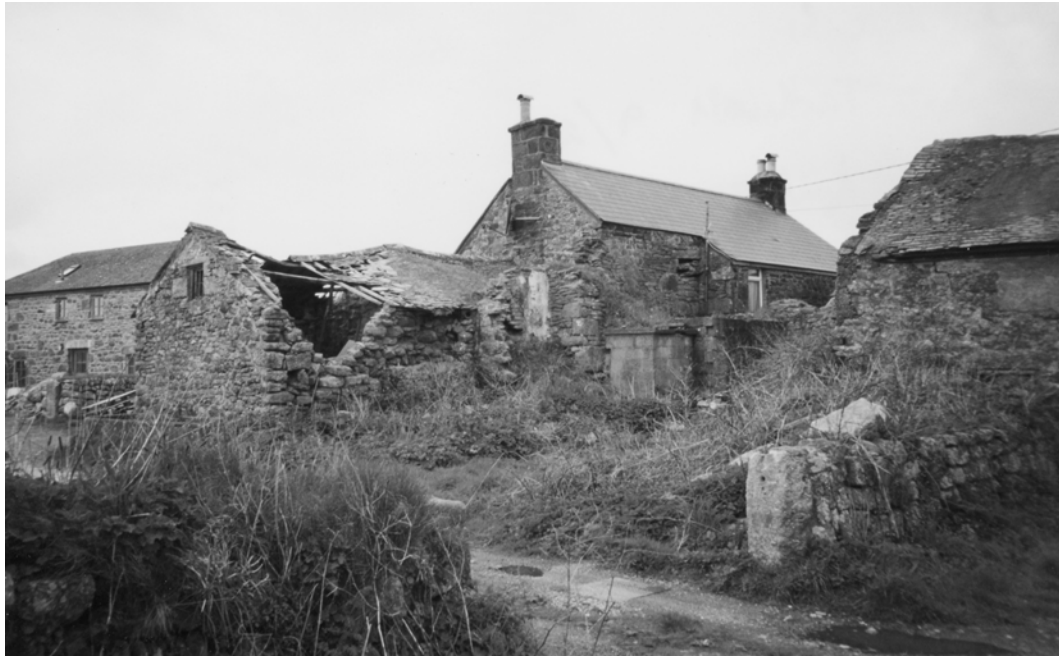
Figure 9 There is much of quality and interest surviving in the village, although under threat, with evidence of the pre-industrial past, and the growth and decline of the village through the C19. Listed buildings allowed to decay in the heart of the settlement, gazetteer items [9] and [20].

The existing listings of the agricultural buildings are inadequate, even those at Botallack Manor, and the complex around Truthwall farm in particular needs greater investigation [20-23]. As regards the industrial phase buildings, apart from assessment of the industrial remains, such as the engine house and other buildings at Wheal Owles, listing should be considered for some of the more complete and unaltered, and particularly earlier, cottages, which may indeed be amongst the earliest in the whole area. These would include the following gazetteer items:

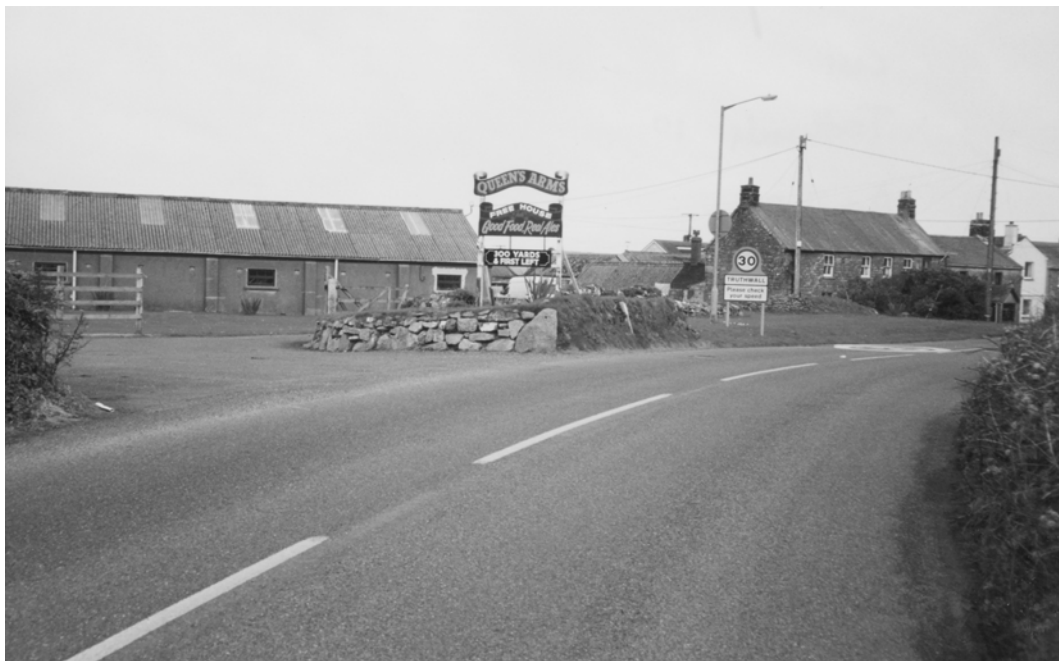
Figure 10 The approaches to an historic rural settlement, and the setting of a listed building, dominated by Highways engineering standard verges, signs and lampposts, poorly detailed agricultural buildings, excessive access and hardstanding measures, and signs advertising a pub in the next village along. Gazetteer item [10] (listed grade II) to the right
