White Gold

Introduction

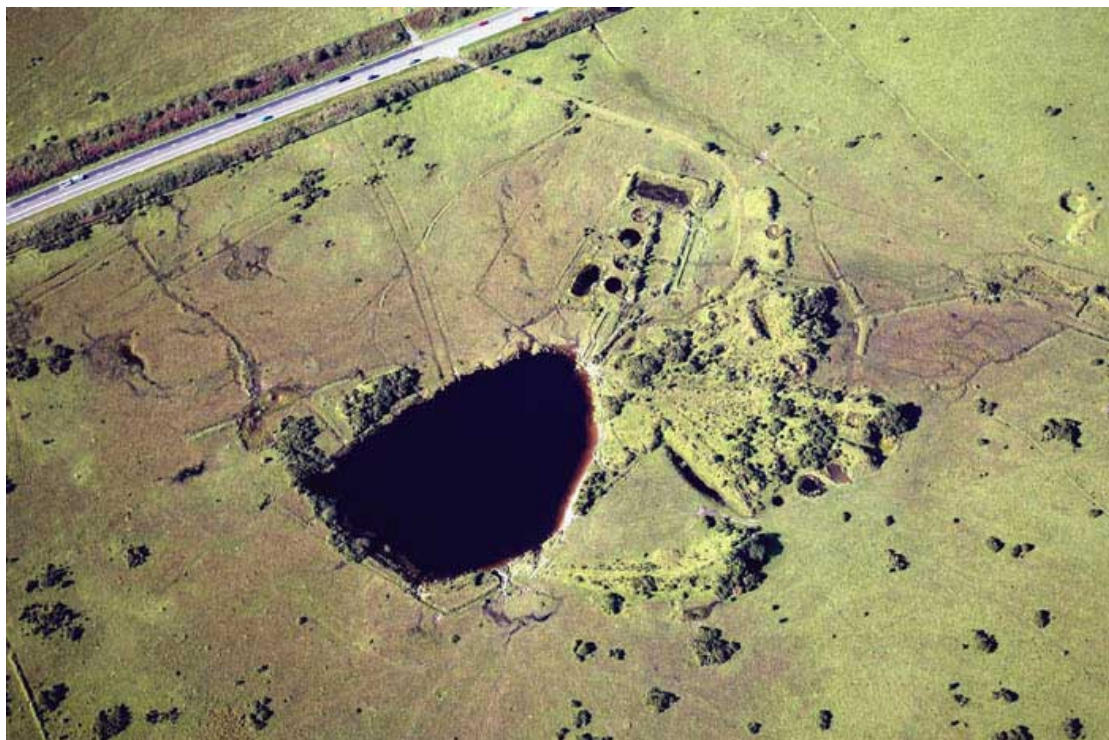
Nineteenth century china clay workings at Burnt Heath, Cardinham. Finger dumps of waste lie to the right of the abandoned pit. Circular and rectangular settling tanks also survive. Photo © Cornwall County Council Historic Environment Service

The waste material left behind in the strake had to be removed. In the early days of the industry this was done by hand but the disposal of waste was later mechanised, with power provided by waterwheel, horse whim (capstans powered by horses walking around a circular platform) or steam engine, the wastes being hauled up a railed incline and then trammed out along flat-topped finger dumps. These dumps are a characteristic feature of early china clay workings but few survive today.

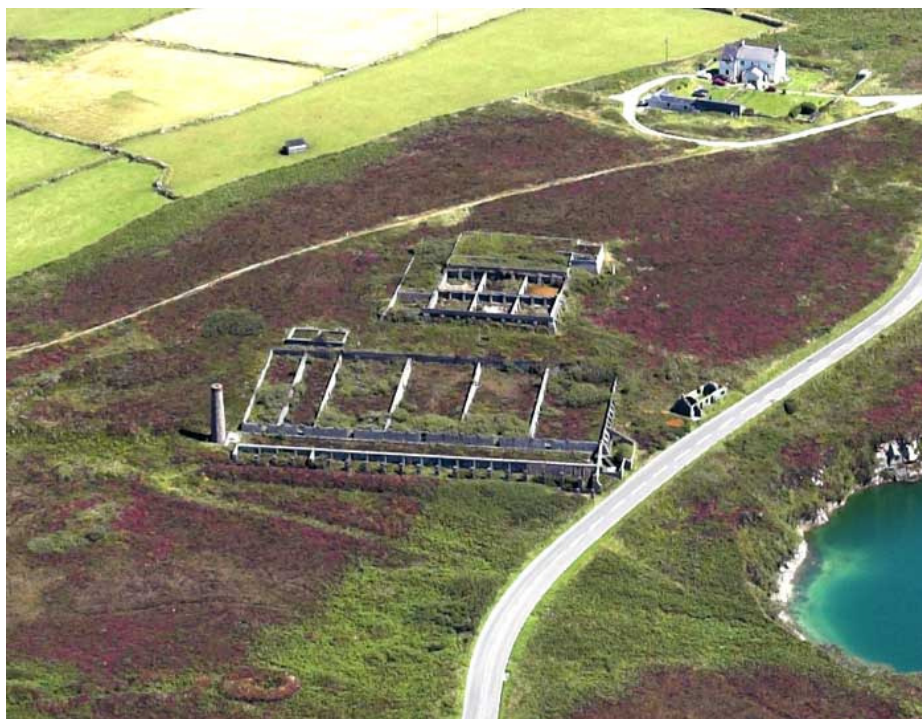
A ruined pan kiln at Leswidden near St Just. Photo © Cornwall County Council Historic Environment Service.

At a stroke the major obstacle to increased production was removed in 1845 with the building of the first pan-kilns for the drying of clay. These were based on the slip kilns of Staffordshire. A furnace at one end of the building was connected to a chimney at the other by a series of brick flues running beneath a floor of porous tiles. The creamy clay was run from settling tanks onto the floor of the kiln. Moisture in the clay was drawn out through the floor tiles and through the chimney in a white plume. During the 1860s and 70s pan kilns developed into a standard form to become a familiar part of the landscape of the clay country.

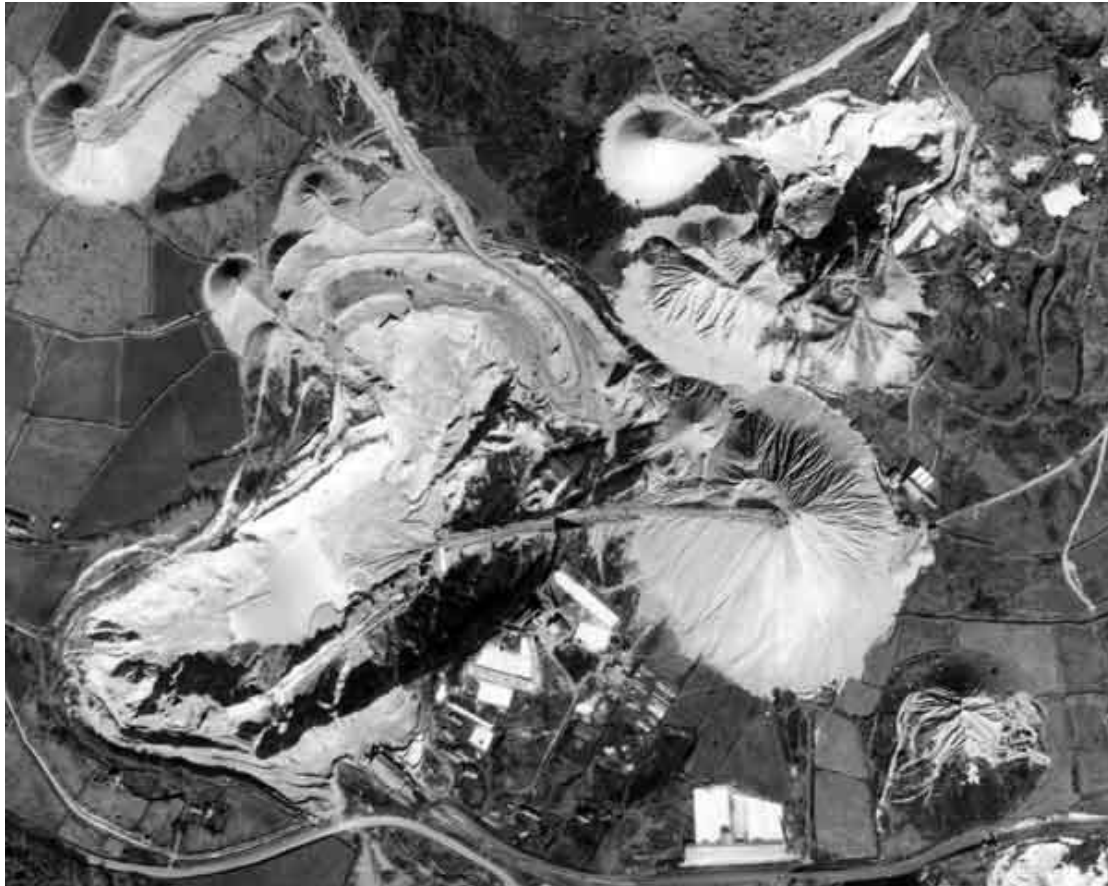
China clay workings around Hensbarrow Downs, showing large sky tips, pan kilns and mica drags (towards the bottom of the photo). Photo RAF 543/2332/F21/0207 ©Crown copyright. MOD

The introduction of mica drags made the process of separating the clay from the unwanted sand and mica far more efficient. Drags consisted of rectangular stone tanks with a very shallow gradient and divided into a series of long narrow channels separated by boards (in later years by concrete dividers). Instead of letting the clay slurry flow into three stepped tanks, it was now directed into the drag. Because of the gradient the flow of liquid clay was slowed allowing the heavy sand and mica to be progressively deposited in the bottom of the channels.
